ARBORIST REPORT

550 Shell Blvd, Foster City, CA 94404

August 2023

Arborist Report for Marriott
550 Shell Blvd.
Foster City, California 94404

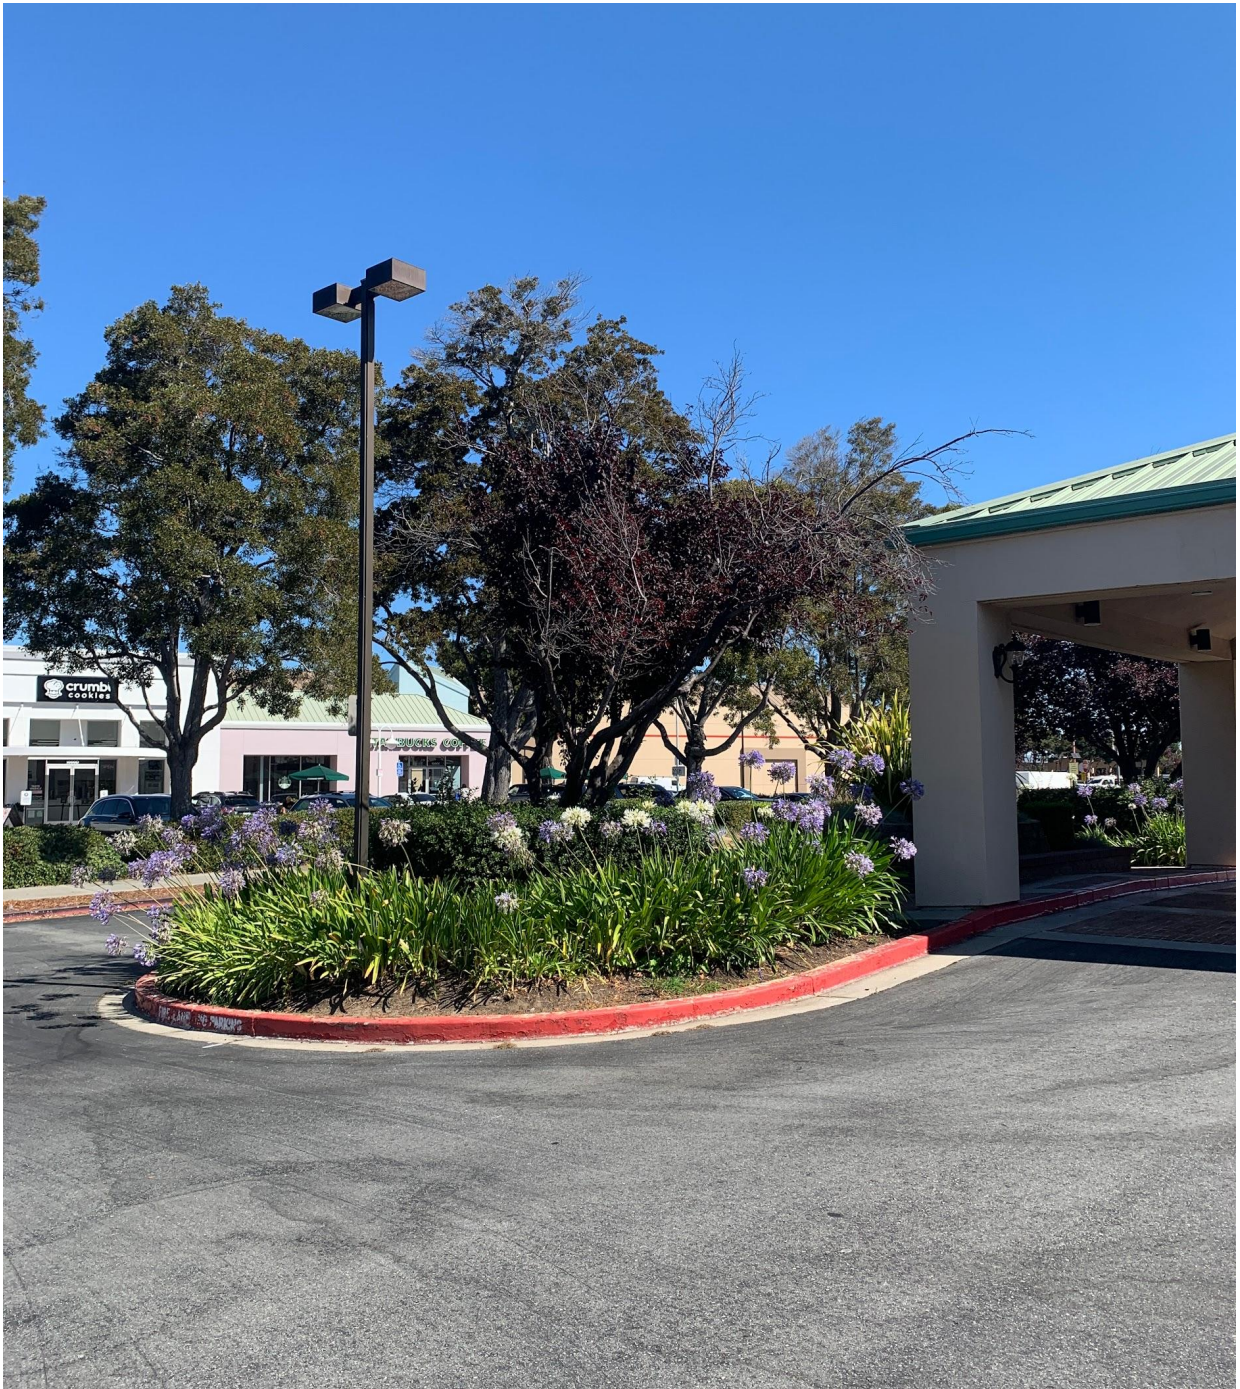
Photo 1. Tree #1, is in poor condition. The tree is located in the front of the property. The landscape plans have this tree set for removal.

- Trees #1-10 are all part of the new landscaping plan and for planning purposes will be removed.
- Tree #1 was in poor health and should be removed regardless of the landscape plans.

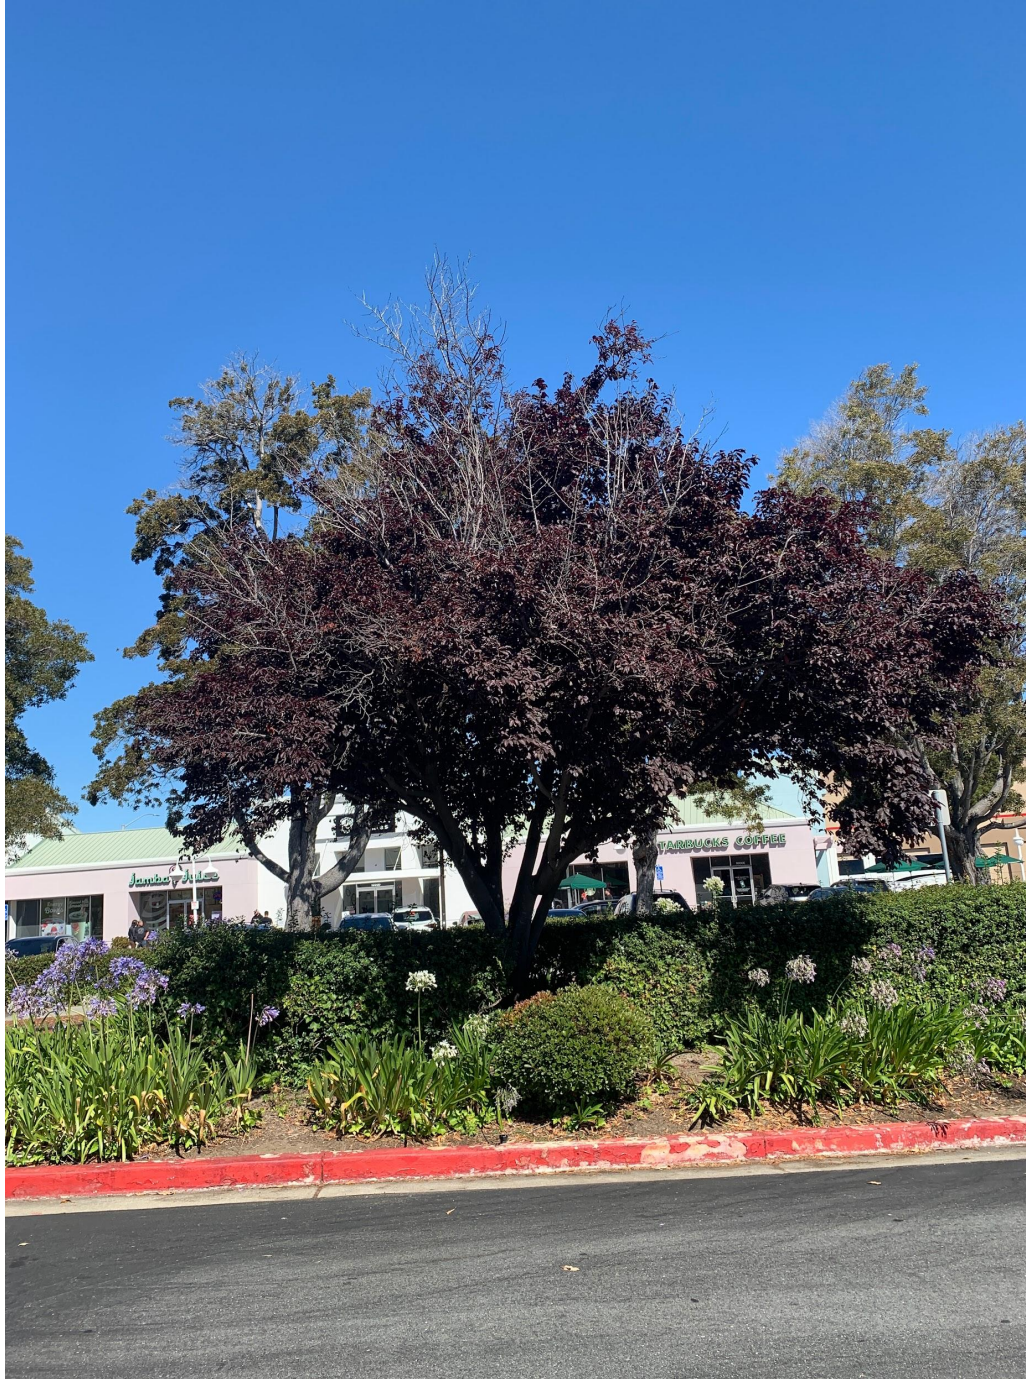
Photo 2. Tree #2, is in fair condition. The tree is located in the front of the property. The landscape plans have this tree set for removal.

- Tree #2 was in fair health, but due to the proposed landscape plan the tree is recommended for removal.
- Trees #3-4 are in good health, but are in poor locations. Once the trees reach maturity they will cause structural damage to the existing building. The trees should be removed.

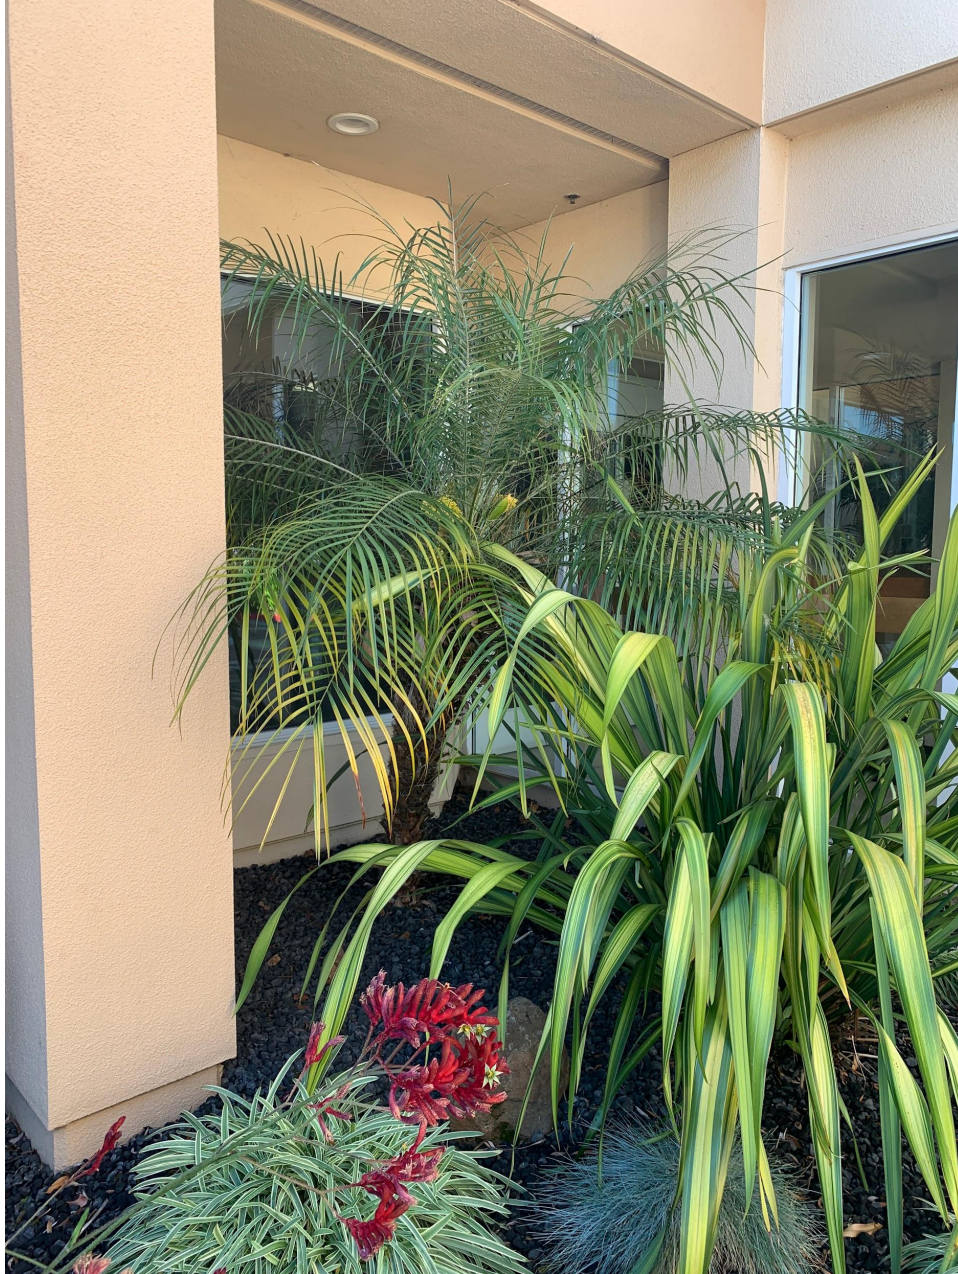
Photo 3. Tree #3, is in good condition. The tree is located in the front of the property. The landscape plans have this tree set for removal, regardless of the site plans, the tree is in a poor location and should be removed.

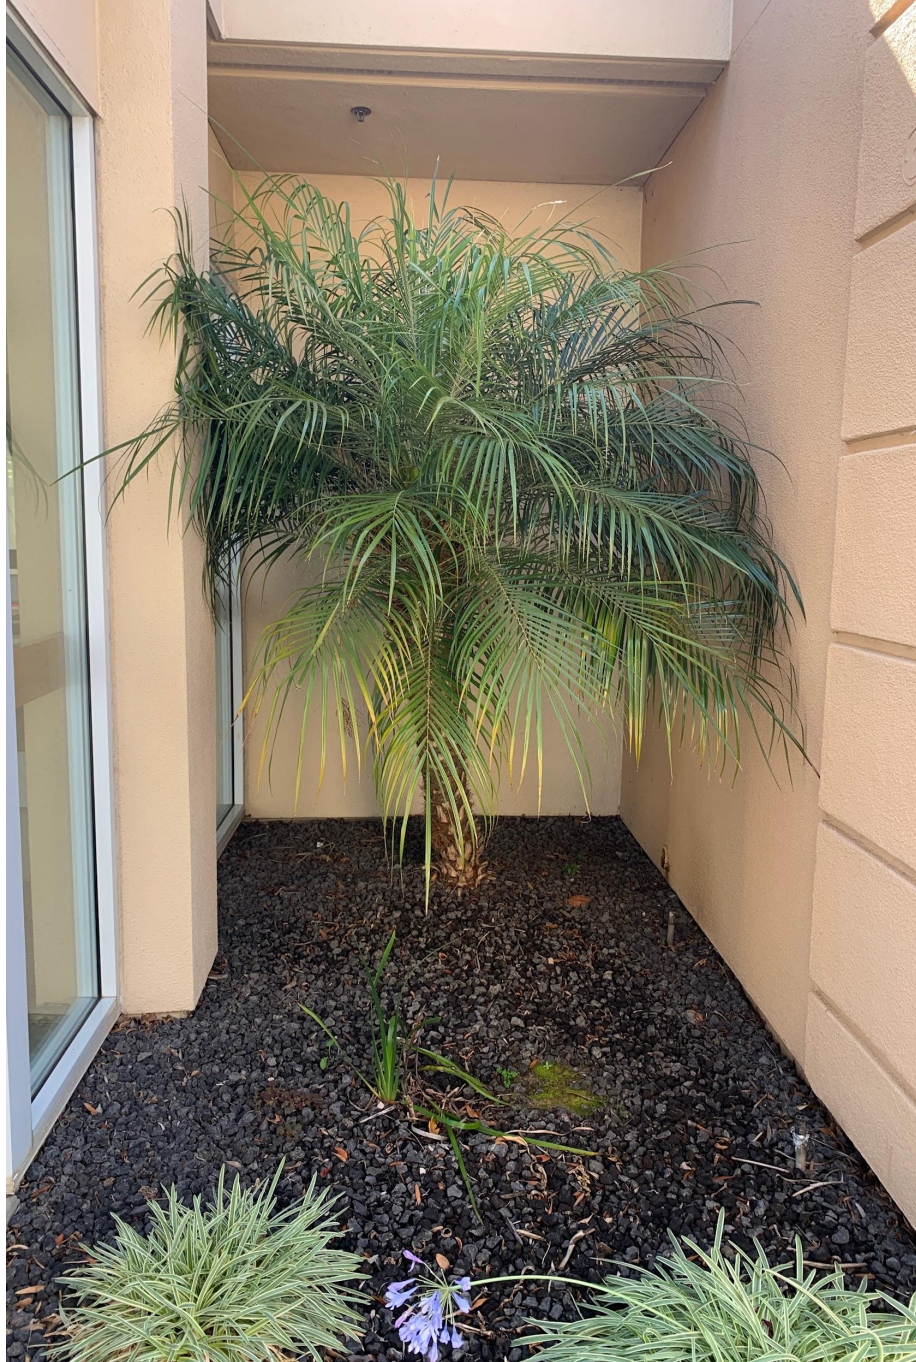
Photo 4. Tree #4, is in good condition. The tree is located in the front of the property. The landscape plans have this tree set for removal, regardless of the site plans, the tree is in a poor location and should be removed.

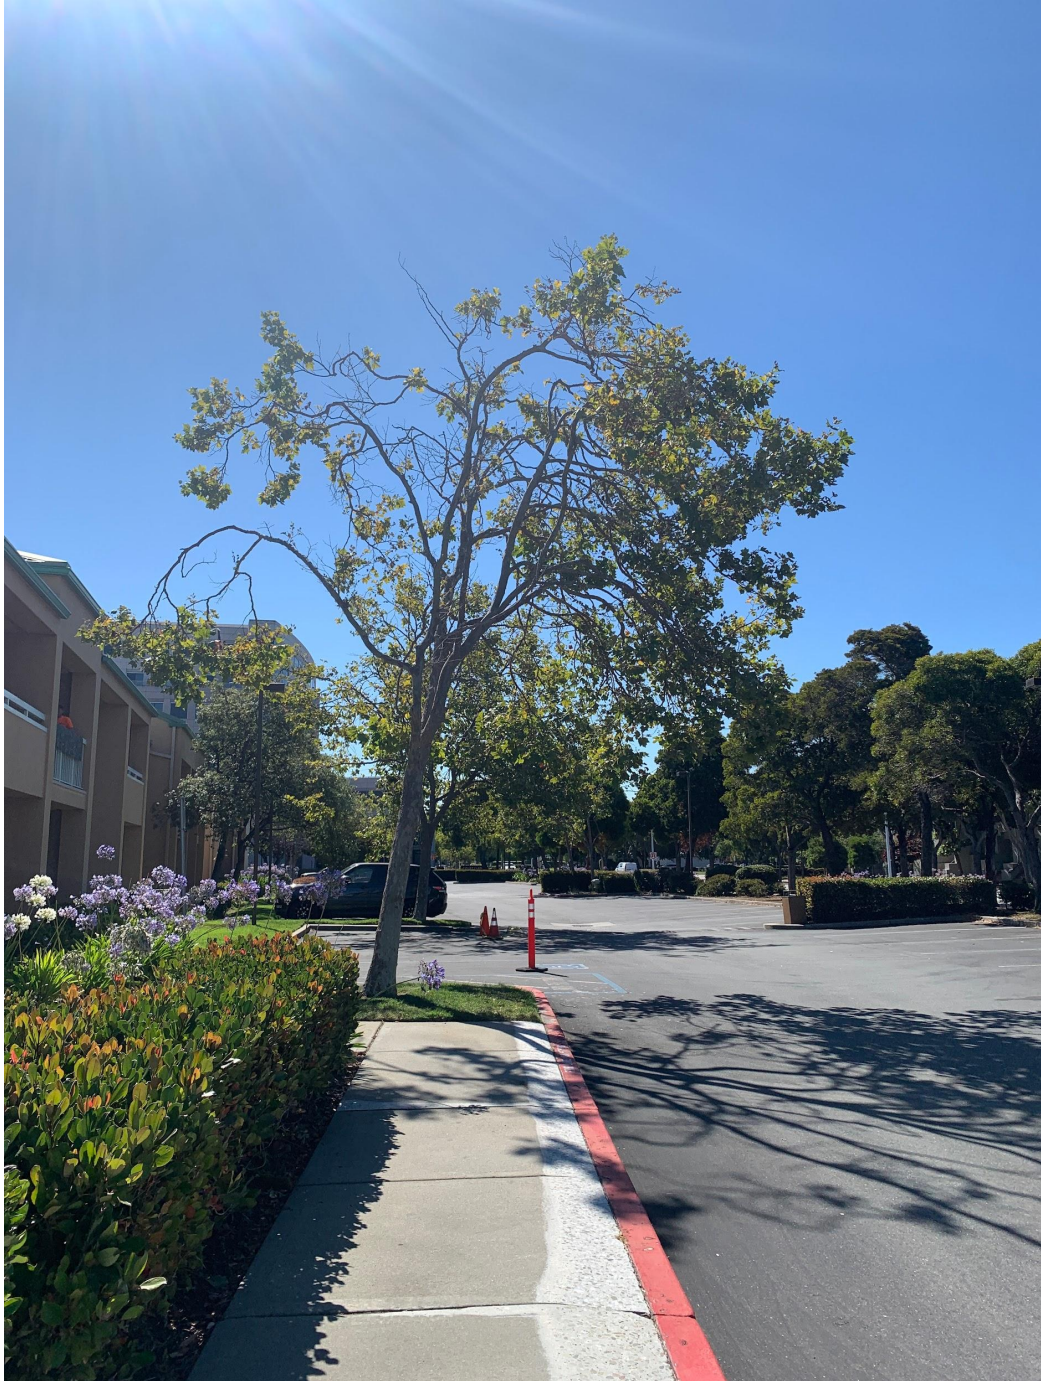
Photo 5. Tree #5, is in poor condition. The tree is located on the side of the property. The landscape plans have this tree set for removal.

- Tree #5 was in poor health and should be removed regardless of the landscape plans.
- Trees #6-9 are in fair condition, but due to the proposed landscape plans the trees are recommended for removal.

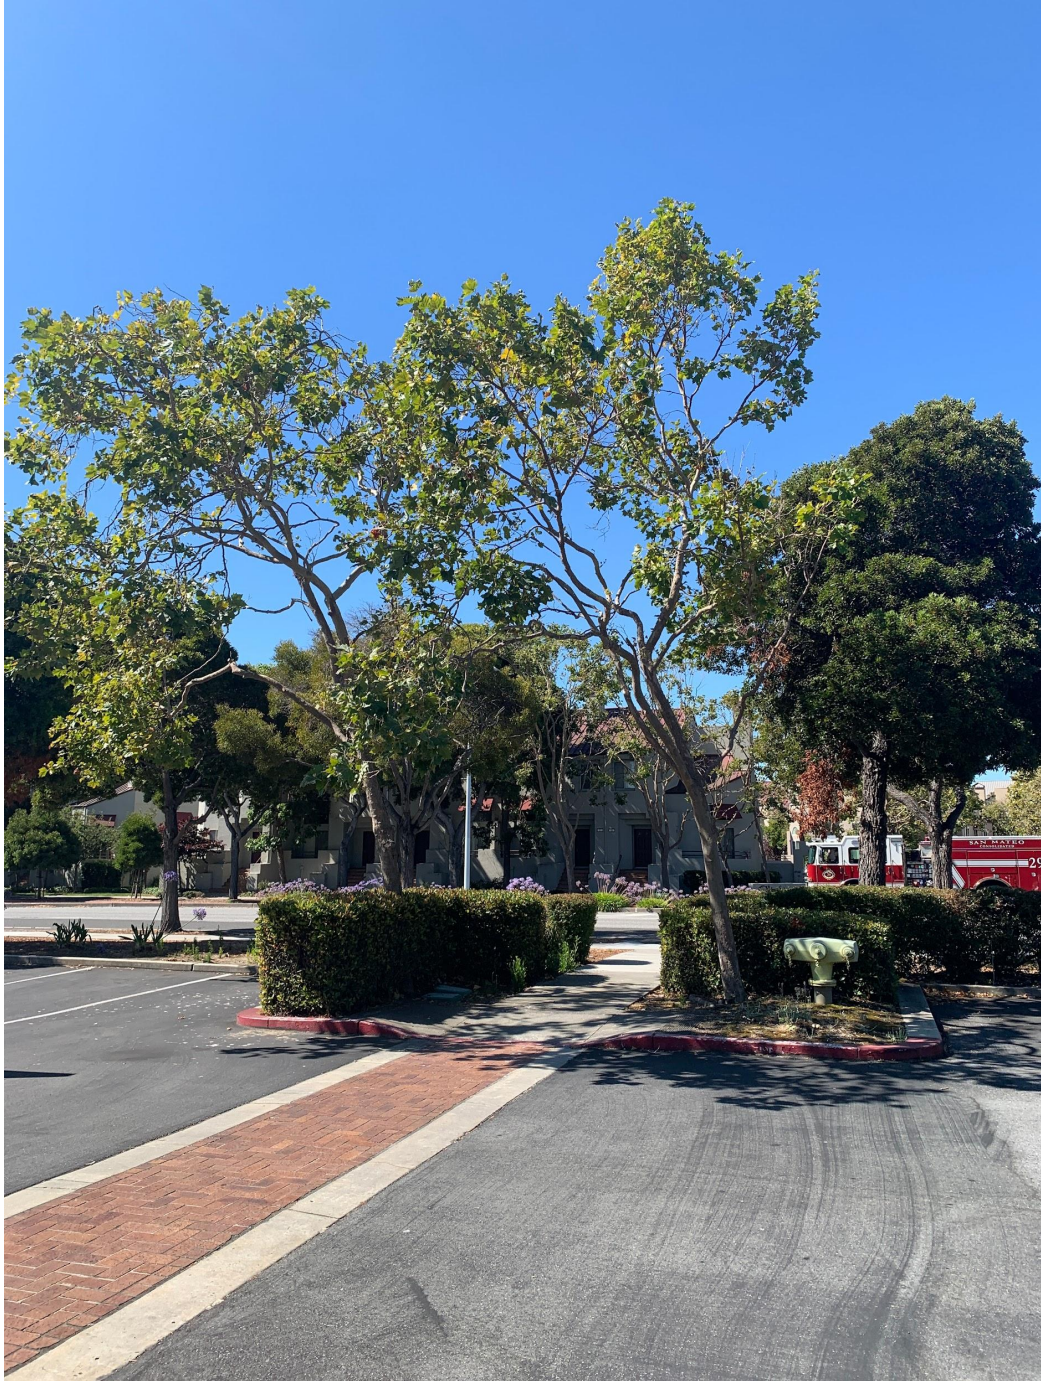
Photo 6. Tree #6 (right) and #7 (left), are in fair and poor condition. The trees are located on the side of the property. The landscape plans have these trees set for removal.

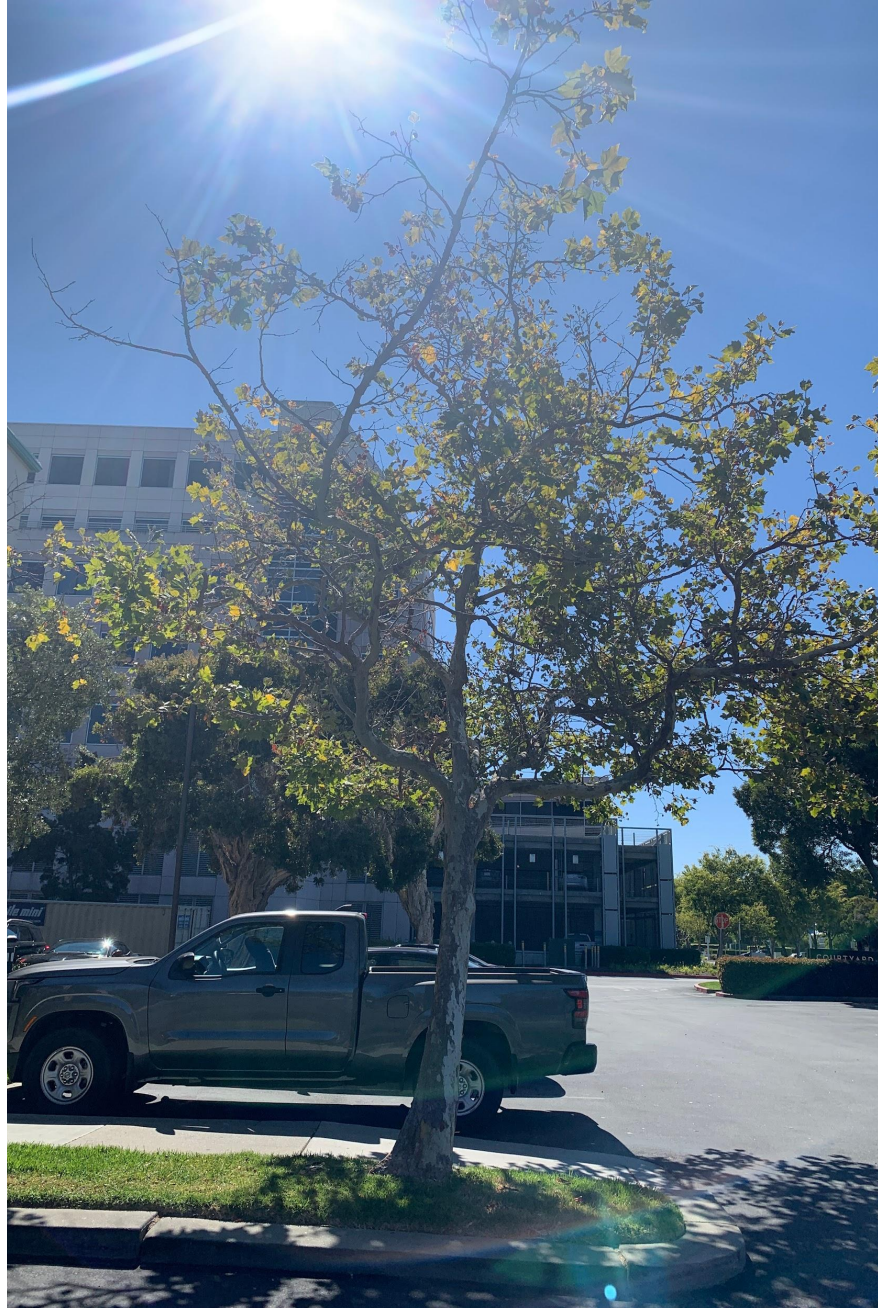
Photo 7. Tree #8, is in fair condition. The tree is located on the side of the property. The landscape plans have this tree set for removal.

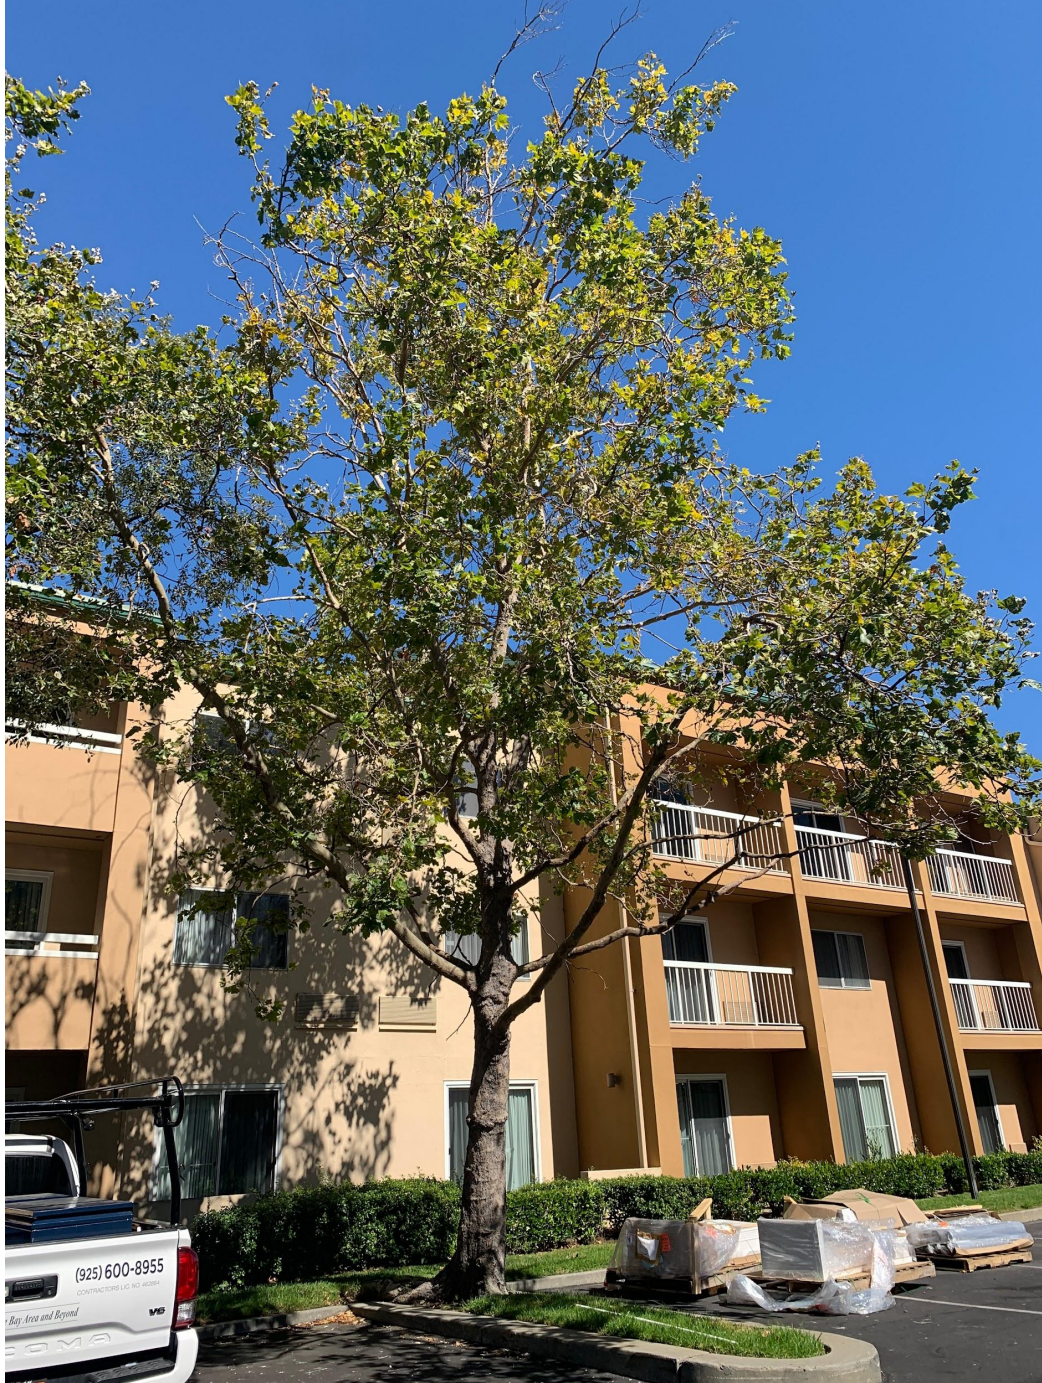
Photo 8. Tree #9, is in fair condition. The tree is located on the rear of the property. The landscape plans have this tree set for removal.

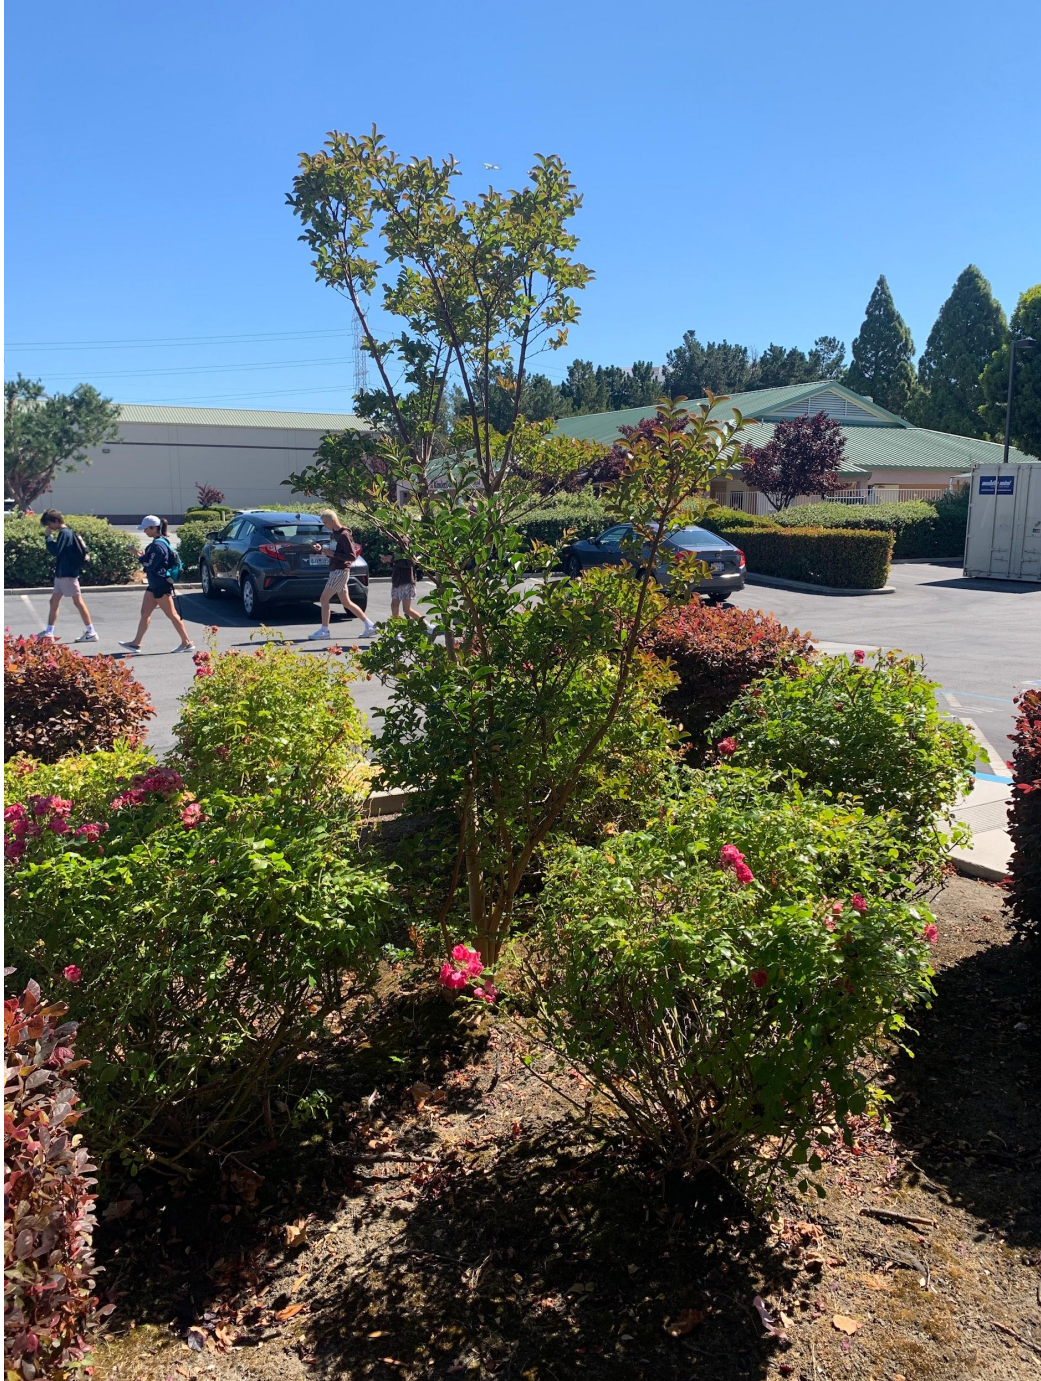
Photo 9. Tree #10, is in fair condition. The tree is located on the side of the property. The landscape plans have this tree set for removal.

10	Crapemyrtle	70	50	50	Y	The tree is very small and almost in shrub form.

- Tree #10 is in good condition, but is a young tree in shrub form. Due to the proposed landscape plans the tree is recommended for removal.
- All of the trees recommended for removal have replacement trees listed on the new landscape plans.
